# Manhole Inspection Summary

Manhole # S41QQ\_027MH

Insp Date: **2/19/07 1:00 PM**

**Location** Address: **2534 ROBB ST**

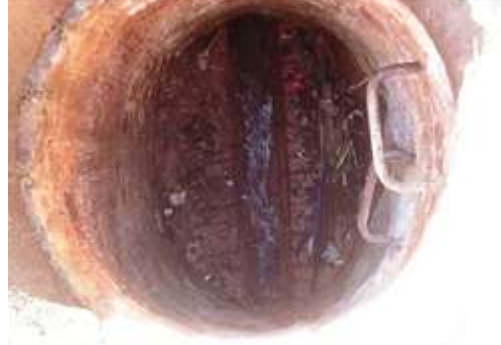
Top View

**Bench** ☒ Exists Material: **Brick** ☐ Parged ☒ **Debris** (not Condition related)

**Steps** Count: **2** Missing: **0** ☒ **Corroded**

**Surcharge** ☒ **Evidence Of Surcharge** Depth: **1** (ft.) ☐ Active Surcharge Present

Corroded steps. Evidence of surcharge - Bench debris.

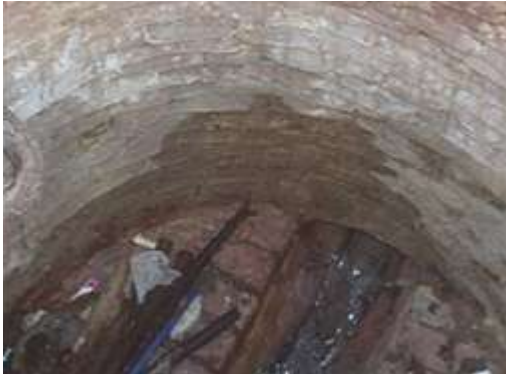
Defect

Infiltration: ☐ None ☐ Joint ☐ Cracks ☐ Mortar ☐ Roots ☒ **Wall**

Barrel infiltration.

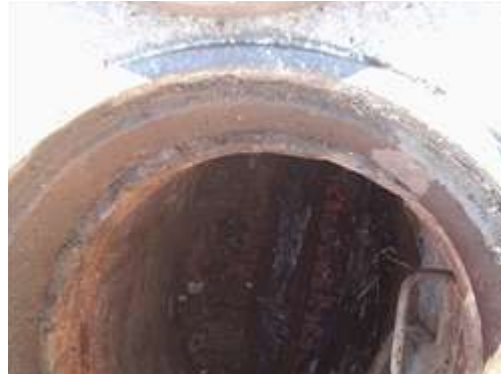
Defect

**Frame** Offset: **1** (in.) Condition: ☐ Sound ☐ Cracked ☒ **Leaks**

Condition: ☐ Sound ☐ Cracked ☐ Root Intrusion ☐ Loose Brick ☒ **Deteriorated**

Infiltration: ☐ None ☒ **Joint** ☐ Cracks ☐ Mortar ☐ Roots ☐ Wall

Frame leaks. Frame offset. Adjustment deterioration and infiltration.

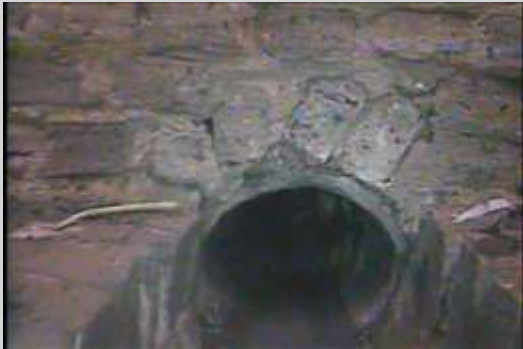
### 8 in. Circular Gravity Sewer Pipe Out @ 12 O'Clock

Infiltration: **Evidence** Pipe Seal Cond: **Unknown**

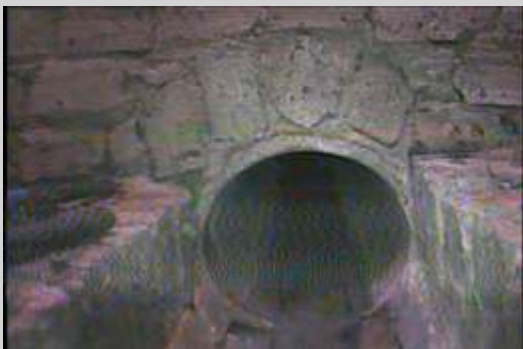
### 8 in. Circular Gravity Sewer Pipe In @ 6 O'Clock

Infiltration: **Evidence** Pipe Seal Cond: **Unknown**
